# UNDERWATER BRIDGE INSPECTION REPORT

STRUCTURE NO. 66510

STRAIGHT RIVER

MINNESOTA DEPARTMENT OF TRANSPORTATION  
UNDERWATER BRIDGE INSPECTION

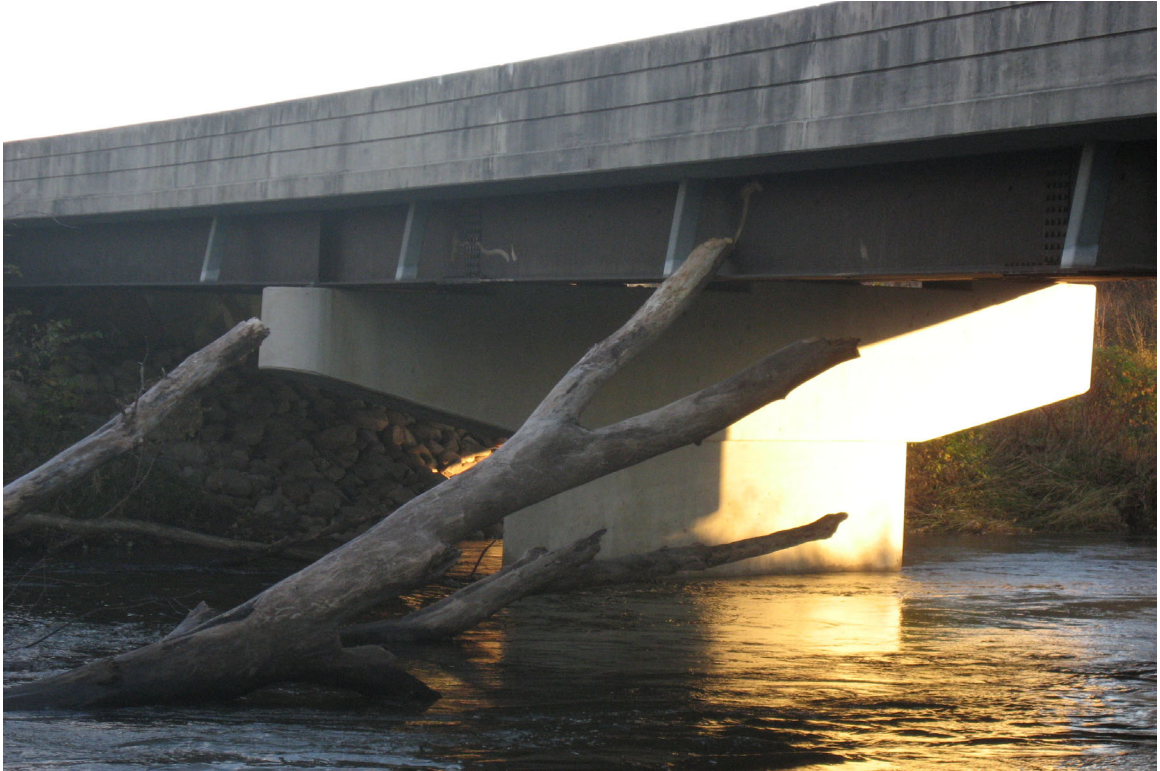
- (A) A heavy accumulation of timber debris was observed at the upstream end of Pier 1, extending down both sides of the pier from 2 feet above the waterline to the channel bottom. A large tree was observed at the span between the piers and resting against the South Fascia, disrupting the channel flow and causing a disposition of bottom material around Pier 1.
- (B) The concrete of both piers was smooth and sound with no defects of structural significance observed.

Photograph 1. View of Pier 1, Looking North.

- (A) The large diameter tree against the superstructure and the heavy drift at the upstream end of Pier 1 should be removed during routine maintenance.
- (B) Reinspect the submerged substructure units at the normal maximum recommended (NBIS) interval of five (5) years.

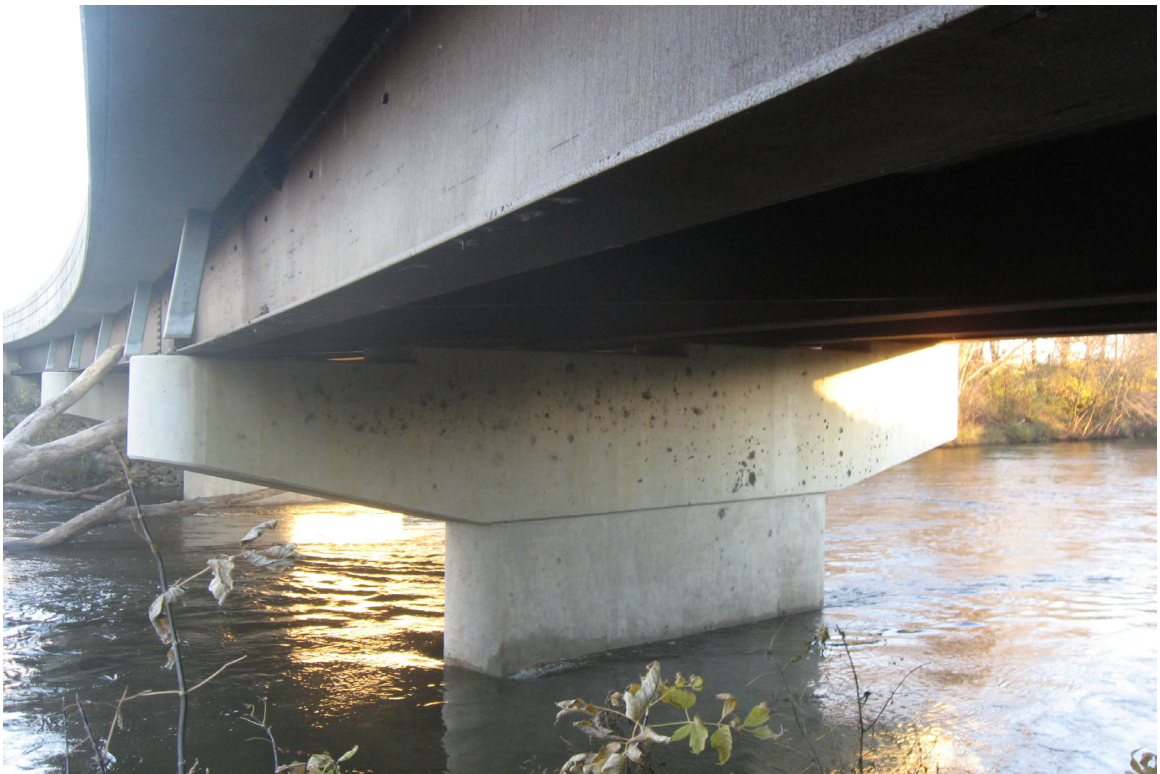
Photograph 2. View of Pier 2, Looking Southwest.

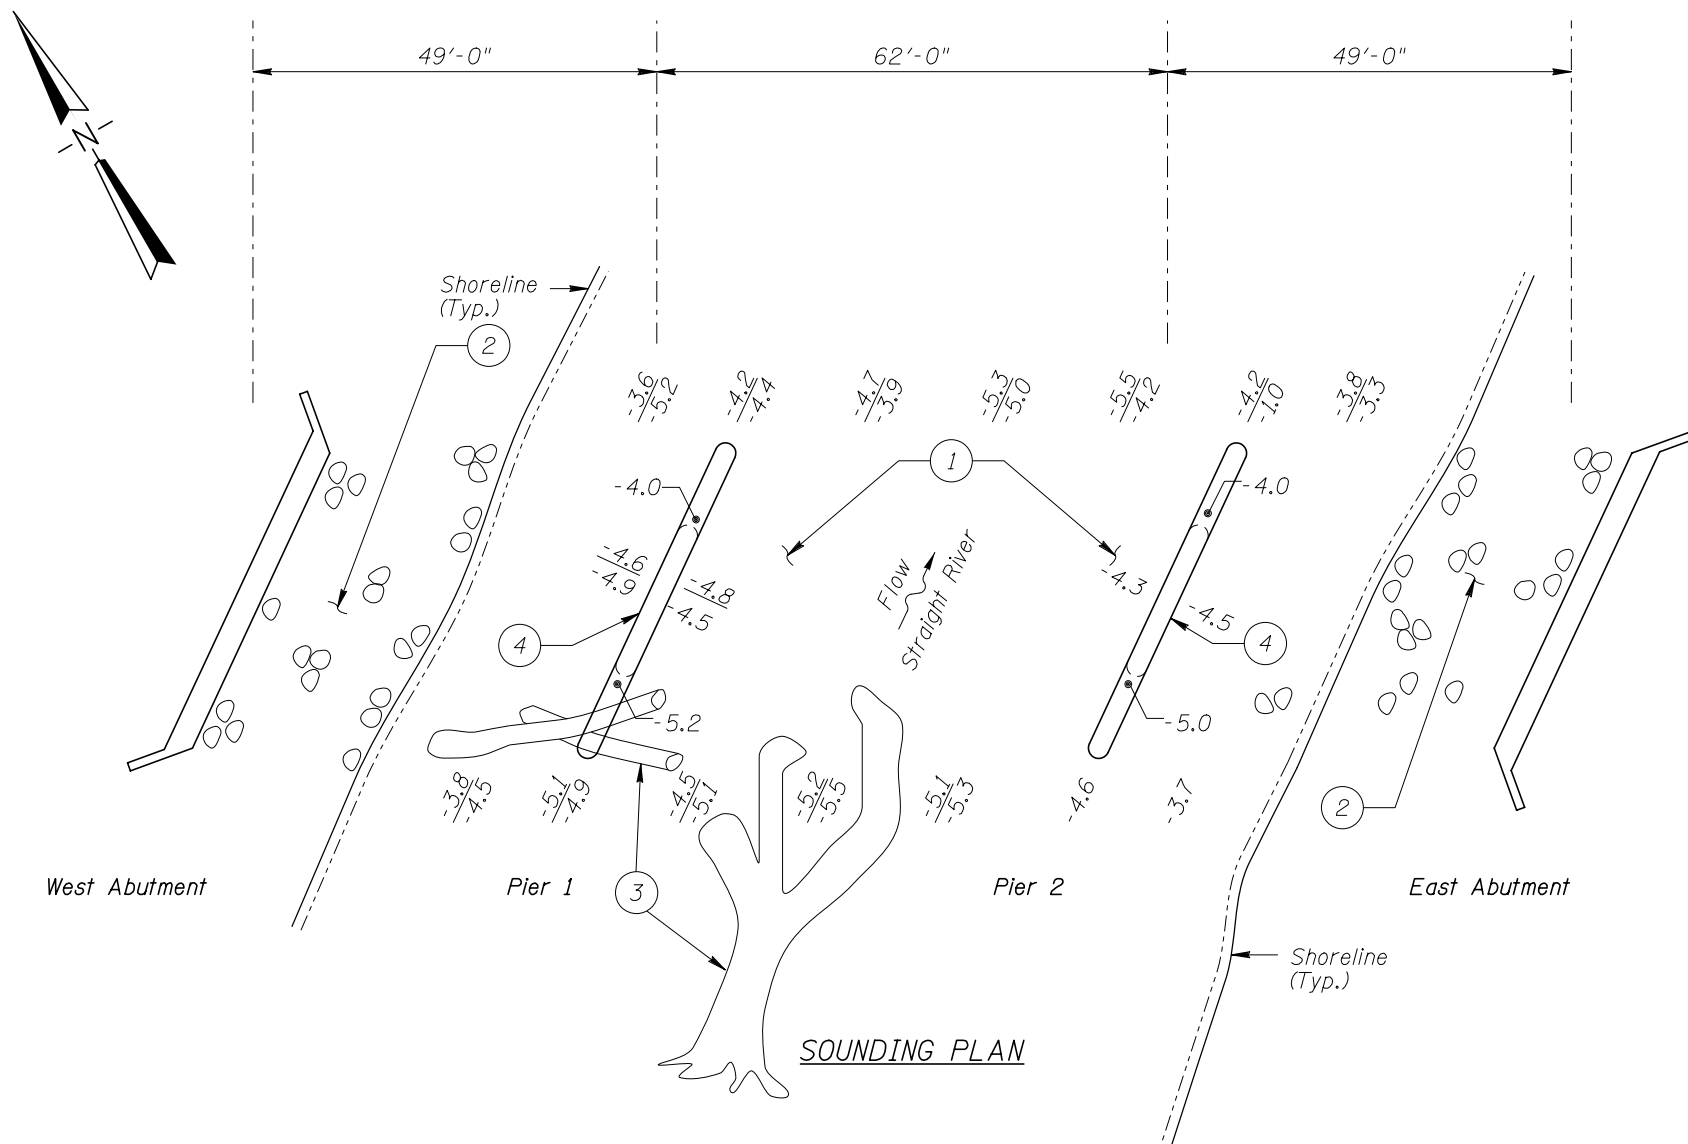
INSPECTION AND SOUNDING PLAN

- The channel bottom material consisted of sandy gravel and scattered 6 inch diameter cobbles with no appreciable probe rod penetration.
- Riprap serves as a protective barrier between the abutments and piers, 2 feet diameter and smaller in size.
- Heavy timber debris accumulation, consisting of logs 1 foot diameter and smaller, was observed at the upstream nose of Pier 2, extending down both sides of the pier from 2 feet above the waterline to the channel bottom. A large tree was also observed at the span between piers and resting against the south fascia.
- The concrete of both piers was smooth and sound with no defects of structural significance observed.
